Manhole Inspection Summary

Manhole # S05AA2021MH

Location Address: **6001 CROSS COUNTRY BLVD** Cross Street: **BAYWOOD AVE**

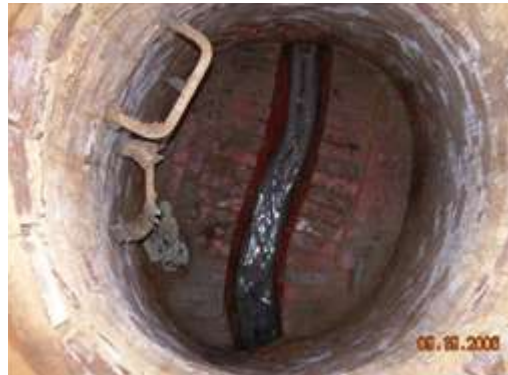
Top View

Adjustment deterioration, loose brick and infiltration. Corbel and Barrel infiltration. Evidence of surcharge - Bench debris.

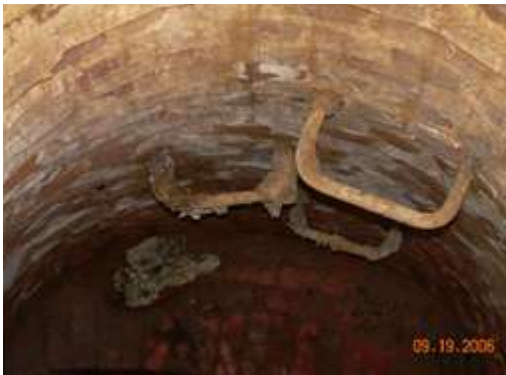
Defect

Adjustment, Corbel and Barrel infiltration. Evidence of surcharge - Bench debris. Corroded steps.

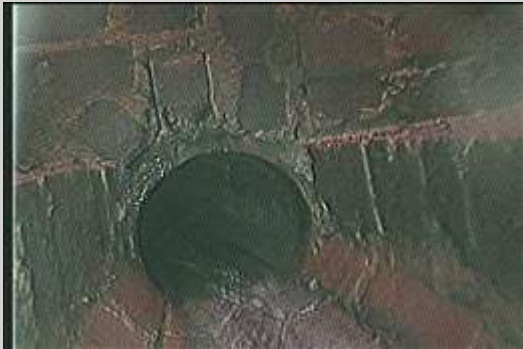
8 in. Circular Gravity Sewer Pipe Out @ 12 O'Clock

Infiltration: **Evidence** Pipe Seal Cond: **Cracked**

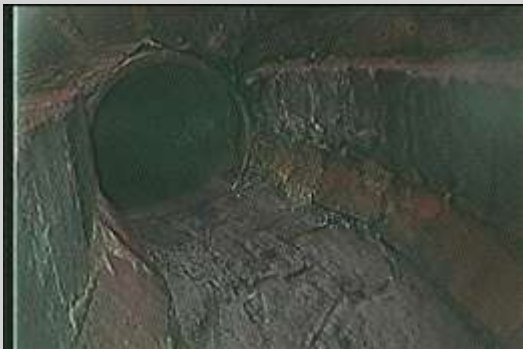
8 in. Circular Gravity Sewer Pipe In @ 5 O'Clock

Channel deterioration.

Infiltration: **Evidence** Pipe Seal Cond: **Cracked**
